APPENDIX D
Site Photographs

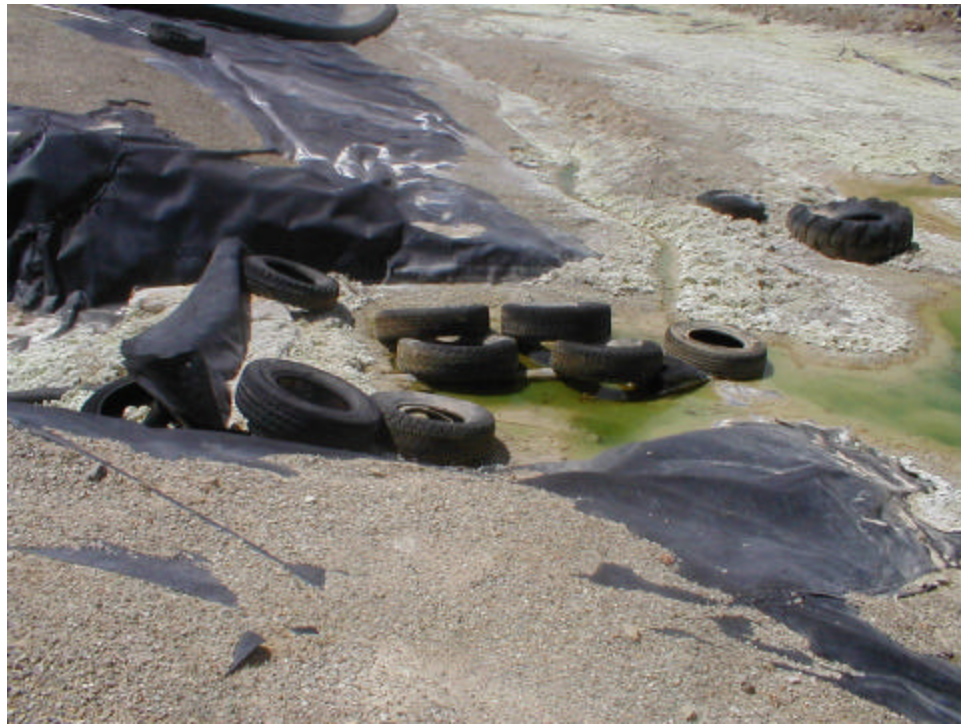
Photo 9
Phase III/4X southeast corner – dam and gravity drain pipe to divert
draindown to VLT system

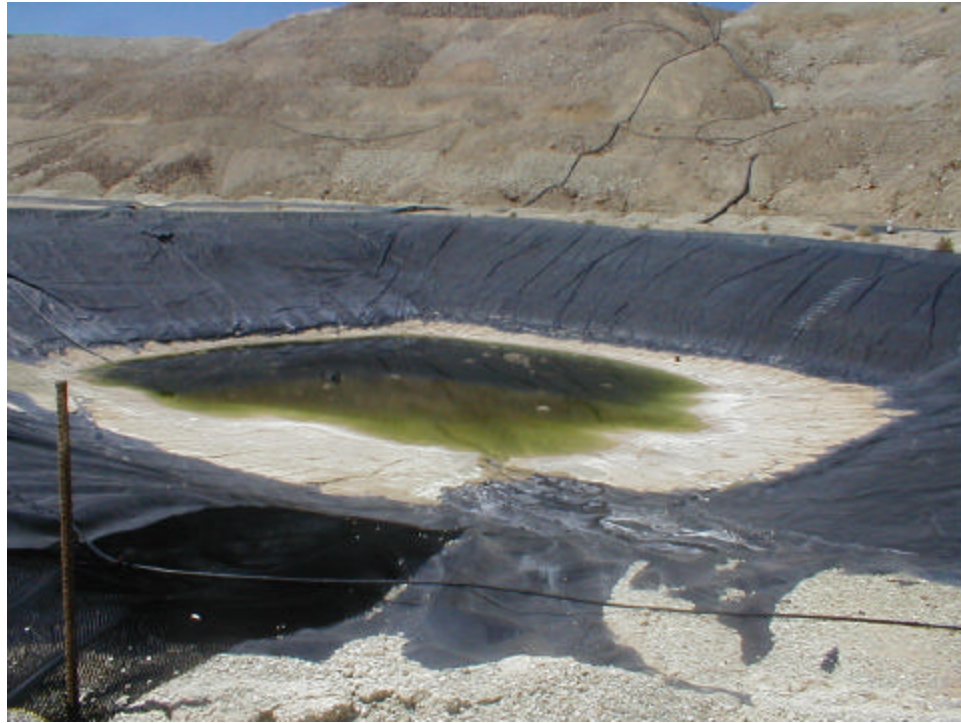
Photo 11
Phase IV-Slot North Pregnant Pond – incidental standing water only, leach
and solution management piping in background

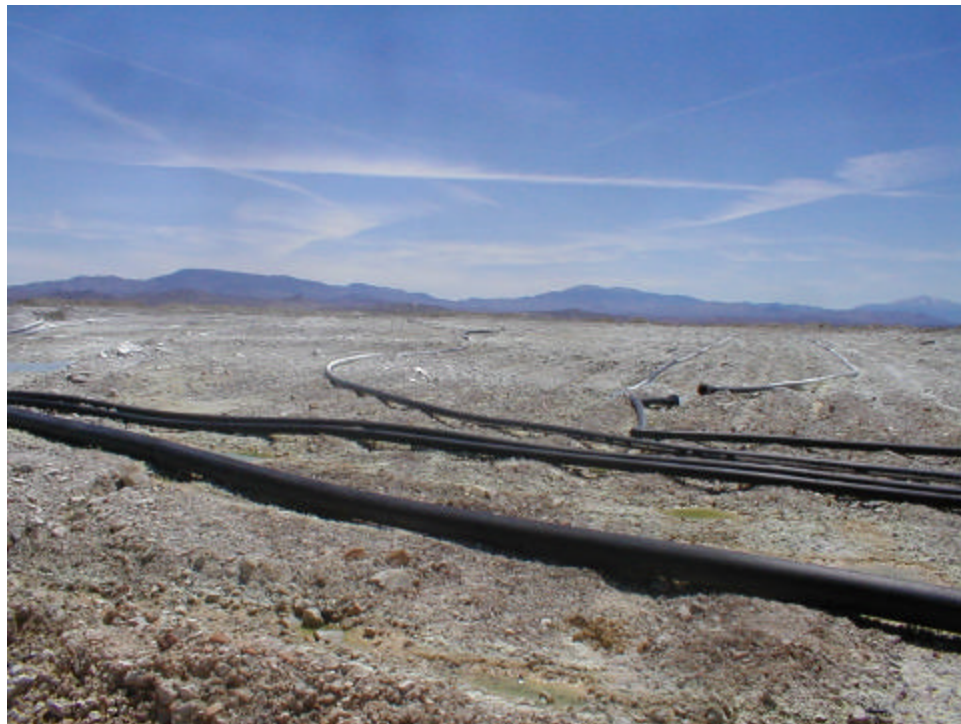
Photo 12
Surface of Phase IV-Slot Heap – evaporation pipes and misters

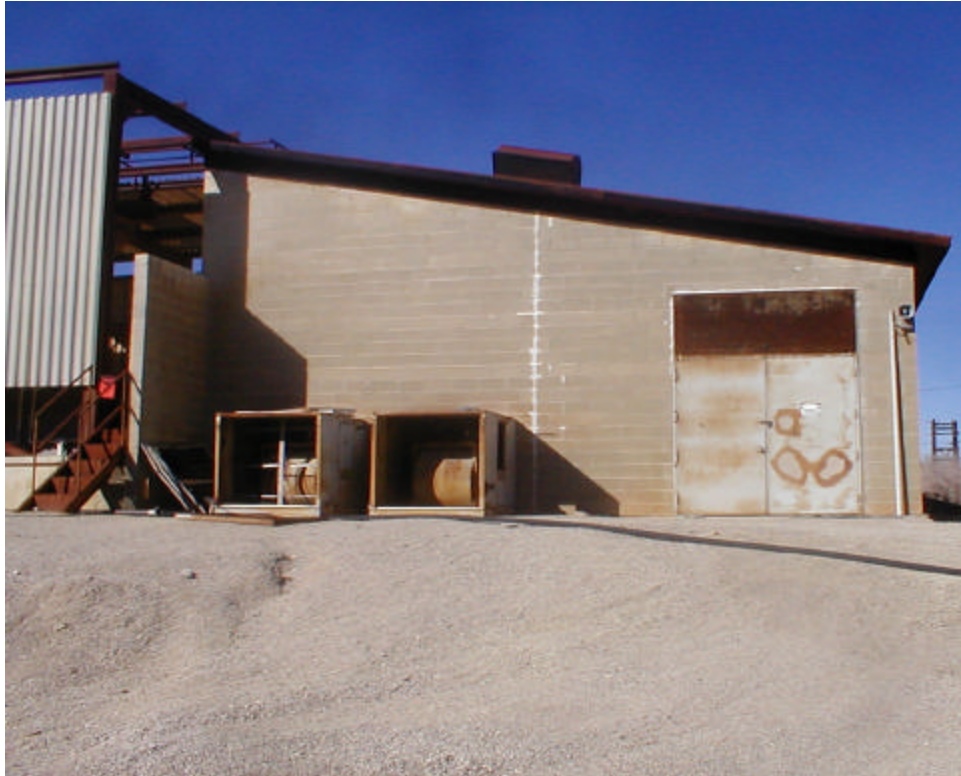
Photo 17
Looking northwest at eastern end of the Electro-Winning Building

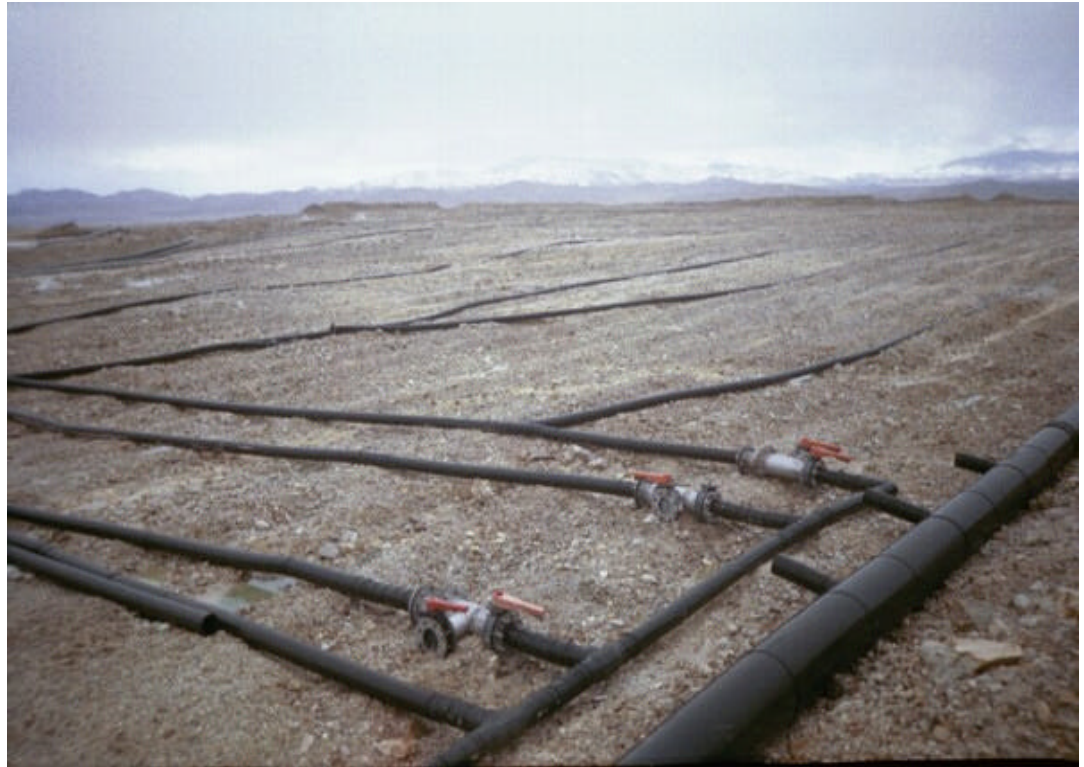
Photo 19
Looking north on top of the Slot Leach Pad, immediately after two days of heavy rainfall.

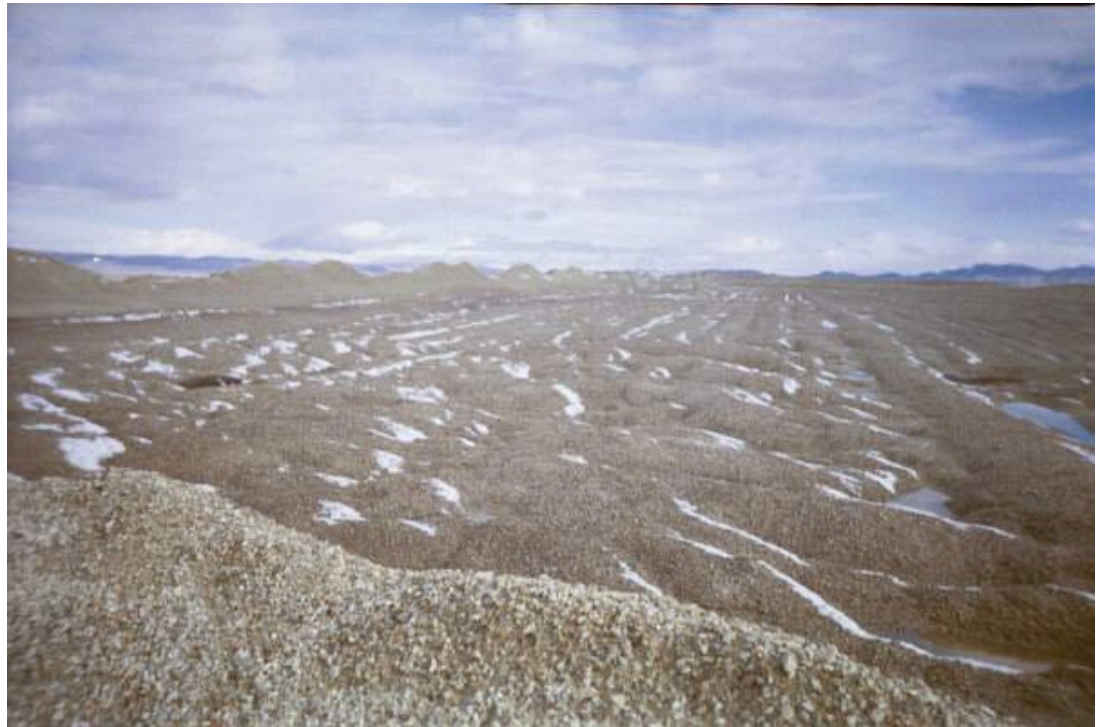
Photo 20
Looking east on top of the Phase III-4X Leach Pad, immediately after two days of heavy rainfall.
